## CHAPTER 6

### LONG-TERM IMPROVEMENTS

SR 99 North: North End of Battery Street Tunnel to N. 145th Street  
Route Development Plan

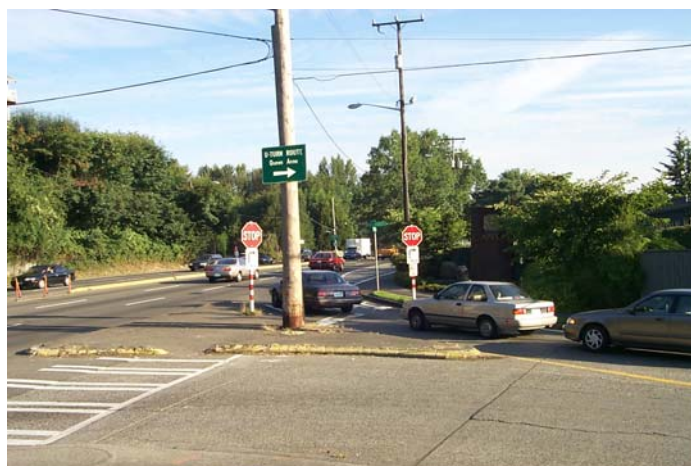
**Picture 6-1:**  
**The intersection**  
**of Halladay Street**  
**and SR 99 North**

Access to and from the Queen Anne neighborhood through the Halladay Street intersection is problematic, especially in the p.m. peak period. Although the posted speed limit is 40 miles per hour, northbound SR 99 North traffic often travels in excess of 50 miles per hour approaching this intersection. Vehicles exiting SR 99 North slow and often queue in the outside through lane. This queuing takes place on a curved section of roadway, which limits sight distance. The combination of slow moving vehicles, limited sight distance with a horizontal curve, and approaching vehicles traveling at 40 miles per hour or faster creates a potentially hazardous situation. This situation has a high potential for rear-end accidents.

Vehicles entering SR 99 North northbound from Halladay Street are also a concern. Currently, vehicles have no acceleration lane at the Halladay Street entrance to SR 99 North so vehicles must directly enter the outside through lane that immediately narrows to 9.5 feet in width. This movement is also on a curve and involves high-speed traffic. This presents a high potential for rear-end and entering-at-angle accidents associated with this movement.

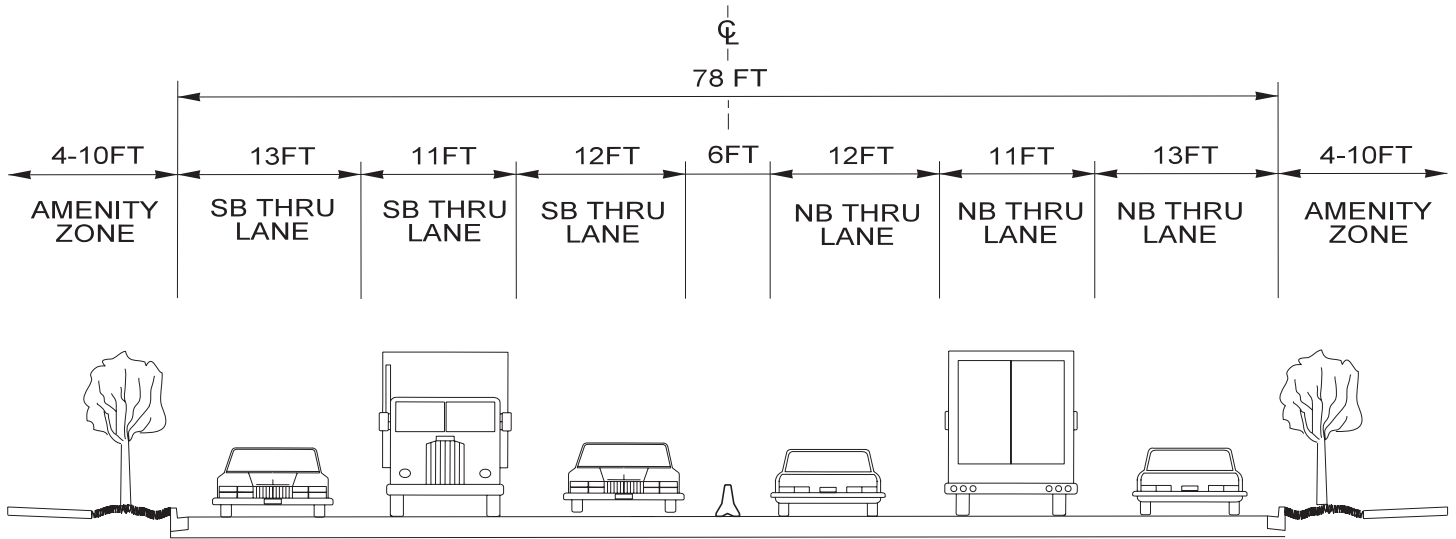
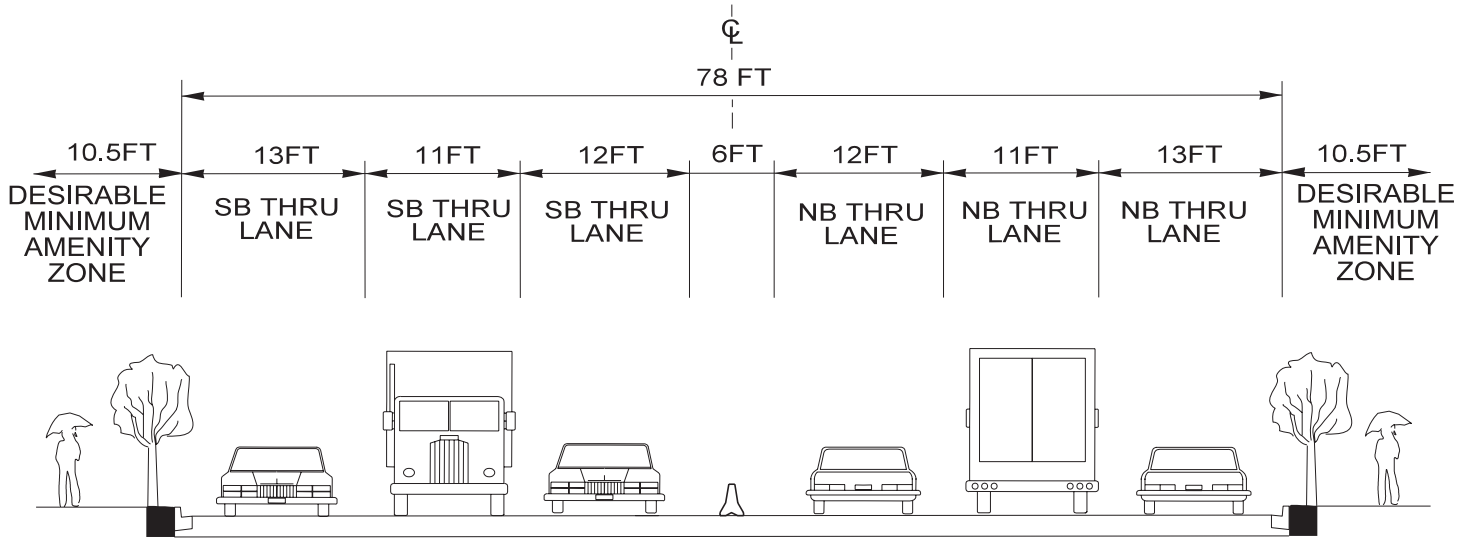
**Figure 6-1**  
**Aloha St to Dexter Way Proposed Future Cross Section**

**EXISTING CROSS SECTION**

**PROPOSED FUTURE CROSS SECTION**

\*THE PROPOSED FUTURE CROSS SECTION WILL BEGIN AT ALOHA ST. BECAUSE DENNY WAY TO ALOHA ST. HAS MANY ADD / DROP LANES

In this predominantly controlled access section of the corridor, the only substantive change proposed for the existing cross-section is a wider amenity zone (sidewalk and planting strip). However, future high accident locations along this segment of the corridor may be improved if it is determined that roadway improvements would reduce accidents. These improvement upgrades could have right-of-way implications for adjacent properties. The estimated cost for the wider amenity zone along this 1.1-mile section of roadway is \$7.1 million and the improvements are shown in Figure 6-1. The cost estimate is in 2002 dollars.

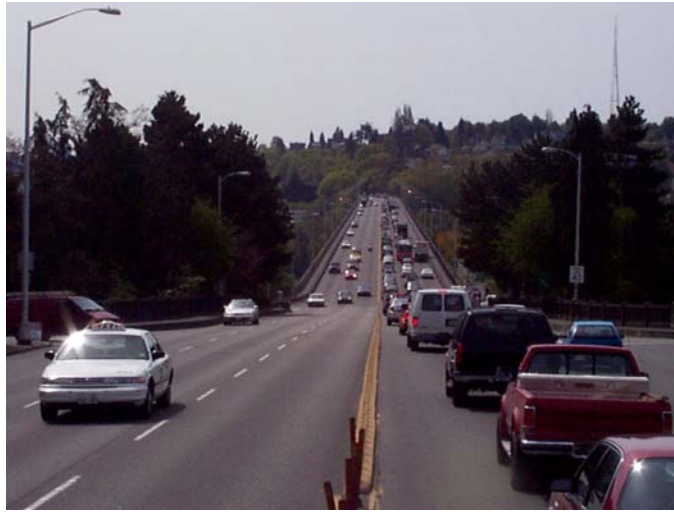
**Picture 6-2:**

**Back up on SR 99 North southbound caused by accident at Raye Street and SR 99 North**

The traffic entering SR 99 North southbound from Raye Street is also problematic. There is no acceleration lane for these vehicles, so they must directly enter the traffic flow from a stop. Coupled with the high volumes and speeds on SR 99 North, this creates the potential for rear-end and entering-at-angle accidents.

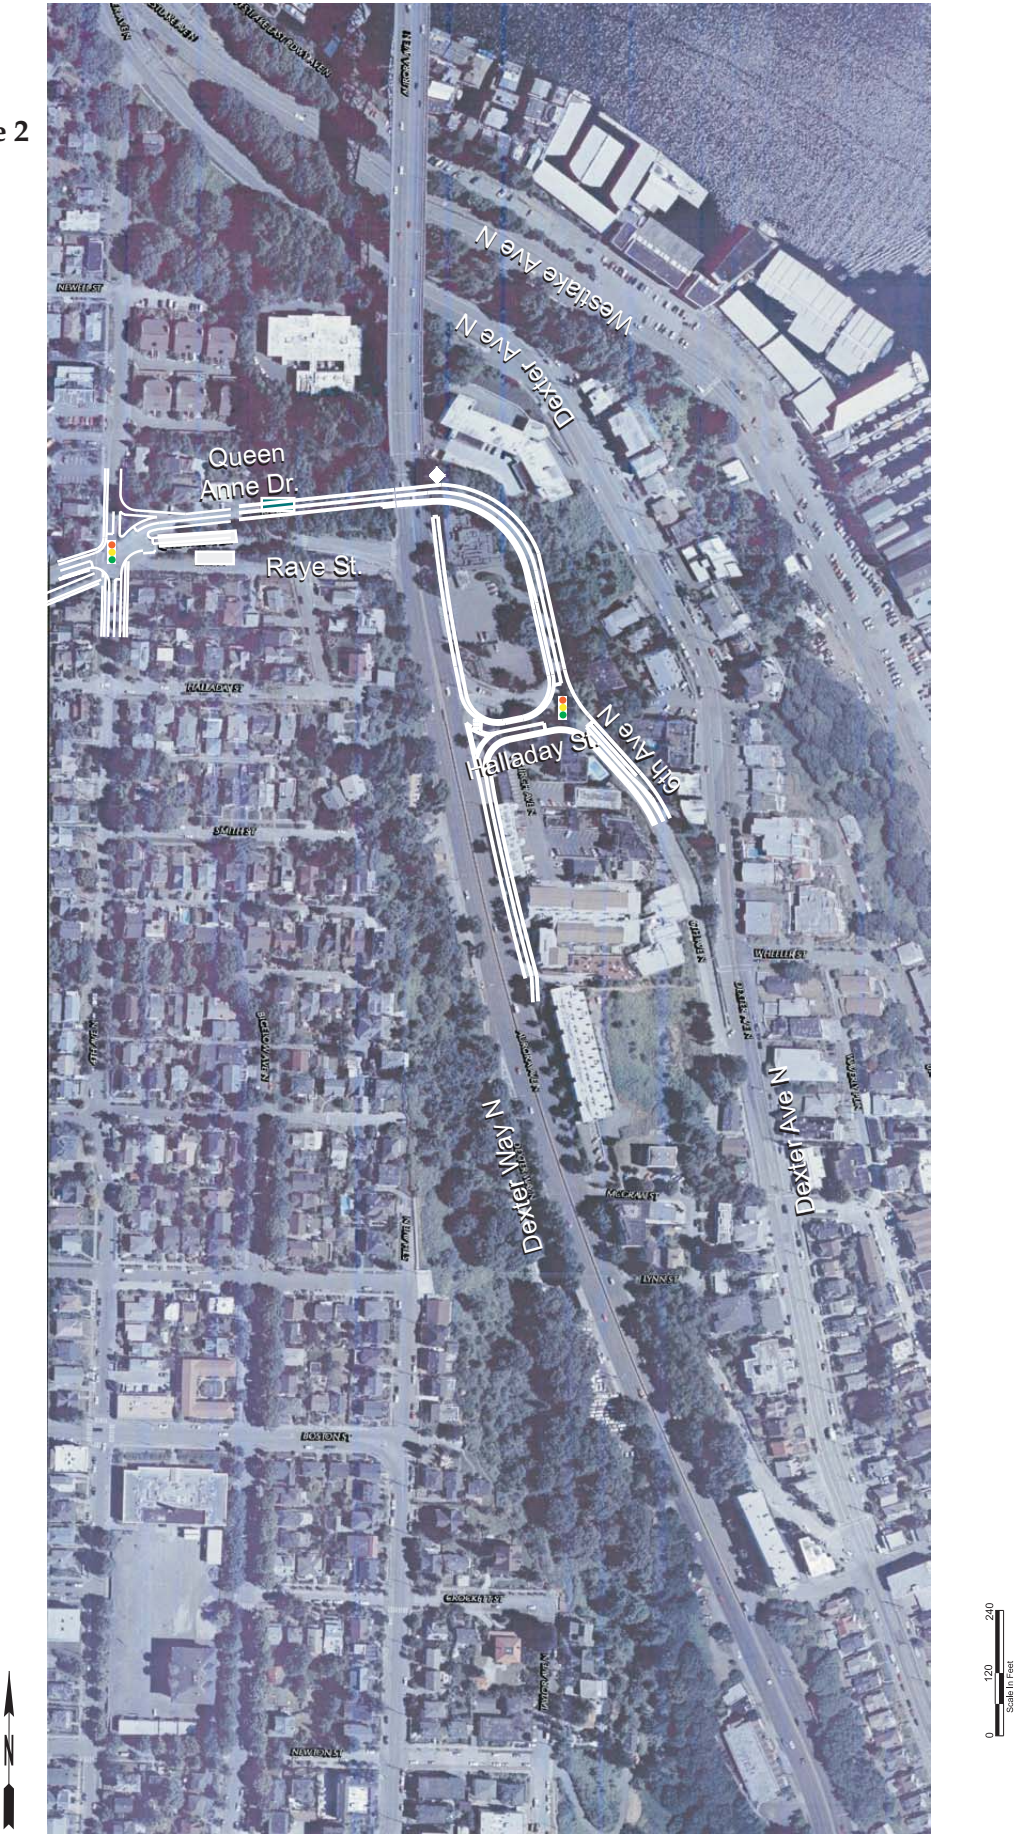
Figure 6-3  
Queen Anne Access Stage 2

Stage 2 of the recommendation would include the Halladay Street recommendation, and would add a signal at the Halladay Street/6th Avenue intersection. The operation of this signal will be determined by the City of Seattle, but it will need to balance the 6th Avenue traffic volumes with the northbound SR 99 North existing volumes.

The final improvement recommendation for this area is to add a new outside deceleration lane approaching Halladay Street and to relocate Halladay Street to the south. See Figure 6-3.

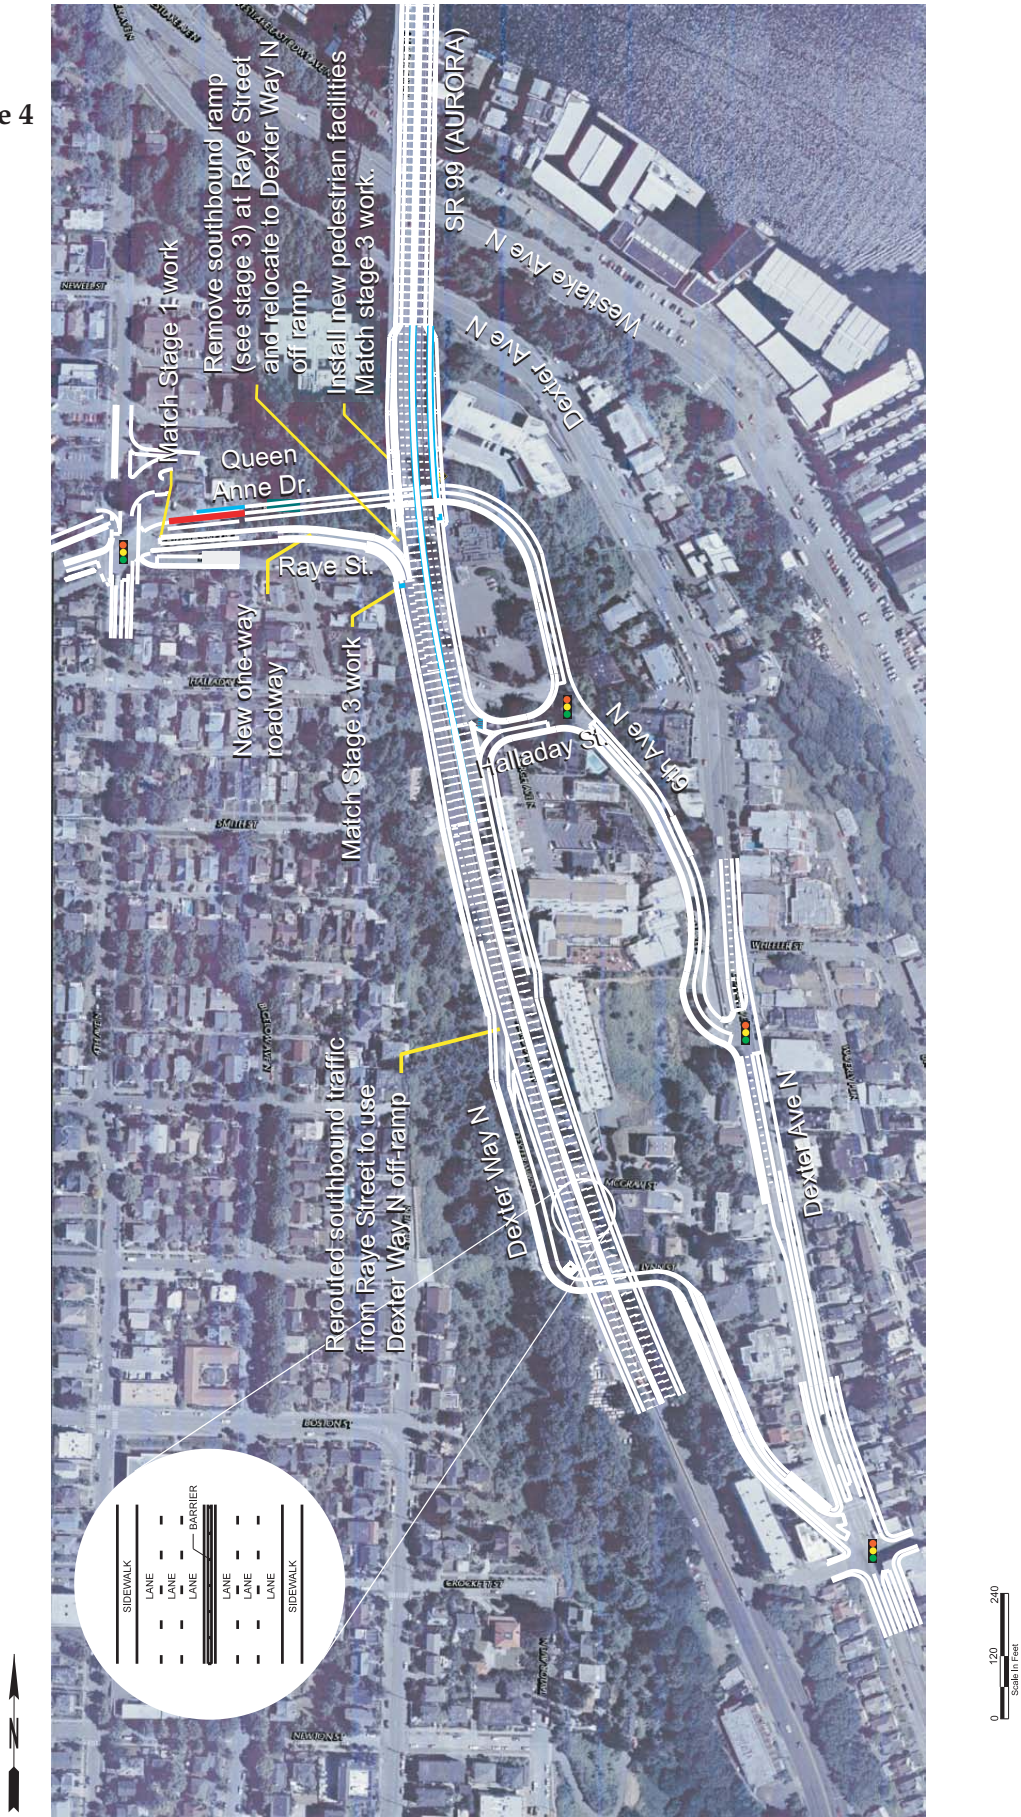
Figure 6-5  
Queen Anne Access Stage 4

Stage 4 of the recommendation would only be constructed as a last resort if the previous stages did not significantly improve traffic flow and reduce accidents in this area. This stage would remove the Raye Street off-ramp bridge constructed in Stage 3 (making Raye Street a one-way street onto SR 99 North southbound) and rerouting westbound Queen Anne traffic to the Dexter Way N. off-ramp. Queen Anne traffic would then travel on Dexter Avenue, 6th Avenue, and Queen Anne Drive to get to the Queen Anne Drive/4th Avenue/Raye Street intersection. Stage 4 would also modify the 5-legged intersection and signal built in Stage 1 to accommodate a one-way eastbound Raye Street.

The traffic signal timing at the intersection of Halladay Street and Queen Anne Drive would need to be revised with the change in traffic patterns caused by the rerouting. The timing of this signal would be determined by the City of Seattle, but would need to balance the rerouted traffic volumes with the northbound SR 99 North exiting volumes. The projected 2030 a.m. and p.m. peak LOS for this location are B and D respectively.

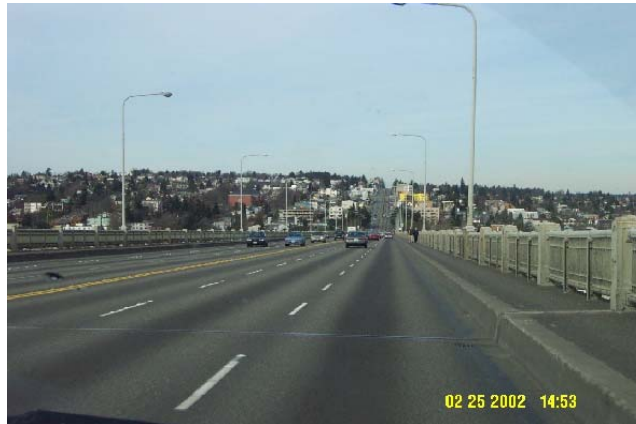
**Picture 6-3:  
Aurora Bridge  
Deck**

The Aurora Bridge area has traffic congestion and is part of a High Accident Corridor (see Chapter 3: Accidents and Safety Issues). The existing Aurora Bridge has narrow lanes (9.5 feet), no median barrier, and no barrier separating the roadway and sidewalk. The lanes are so narrow that buses and other large vehicles sometimes straddle two lanes while traveling on the bridge. The combination of narrow lanes, lack of a median barrier, and driver actions (speeding, following too close, etc) creates a risk for sideswipe, rear-end and head-on traffic accidents. Over 80% of the accidents on the bridge are either sideswipe or rear-end accidents. The narrow lanes also reduce the traffic capacity of the roadway. Rear-end accidents also occur on the bridge due to congestion from the Raye Street intersection to the south and the N. 38th Street off-ramp to the north.

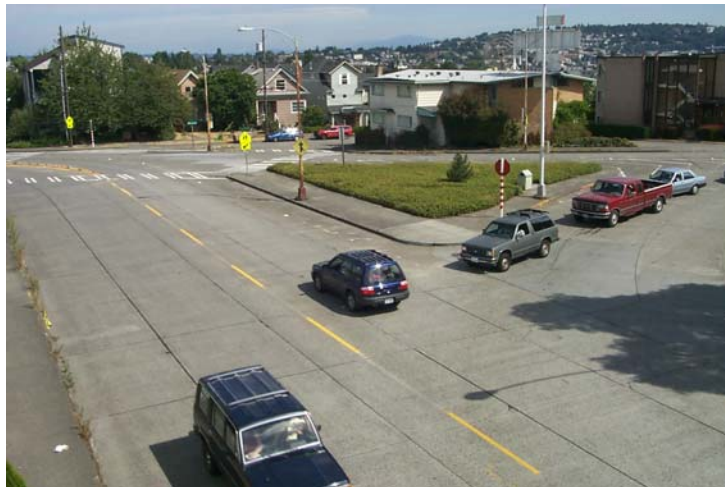
**Picture 6-4:**

Both Bridge Way N. and N. 38th Street have operational and access issues. Currently, the off-ramp intersections are unsignalized and have several conflicting movements. The northbound off-ramp onto Bridge Way N. often has traffic queues back onto the Aurora Bridge in the p.m. peak period. Access from this area to northbound SR 99 North is very problematic for large vehicles. Access to northbound SR 99 North in this area is via N. 38th Street; however, the tight turning radius restricts trucks and large vehicles from using this location. As a result, trucks detour onto Stone Way through the Green Lake Park and access northbound SR 99 North at Green Lake Way North.

**The intersection  
of Bridge Way N.  
and N. 38th Street**

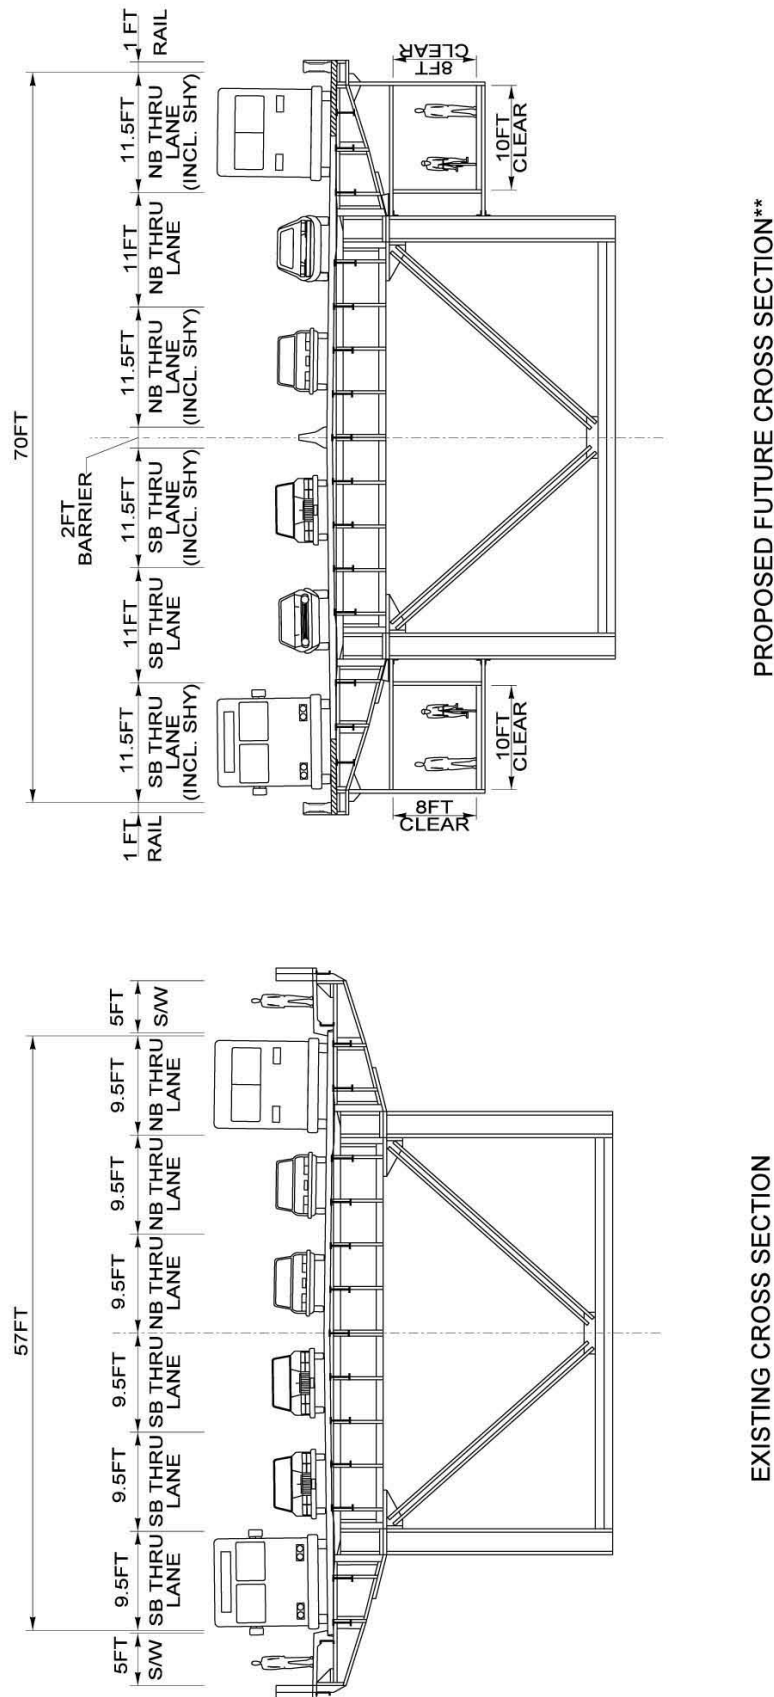
Figure 6-6  
Aurora Bridge Future Cross Section

The proposed bridge improvement (Figure 6-6) would widen the lanes from 9.5 feet to 11.5 feet for the curb and inside lane and 11 feet the middle lane. A median barrier would be added to the bridge and approaches, and would connect to the existing barriers at the N. 38th Street and the Halladay Street intersections. The proposed
